Structure No: 3643 - PHOTO SHEET

mainroads
WESTERN AUSTRALIARoad Name: Trevena Rd
Crossing: Preston RiverLGA: Donnybrook - Balingup
SLK: 0.69Inspection Date: 24-Jan-2018
Inspector: Jarrod Pink

DETAILED TIMBER BRIDGE INSPECTION SUMMARY

**TIMBER BRIDGE
DETAILED INSPECTION REPORT**

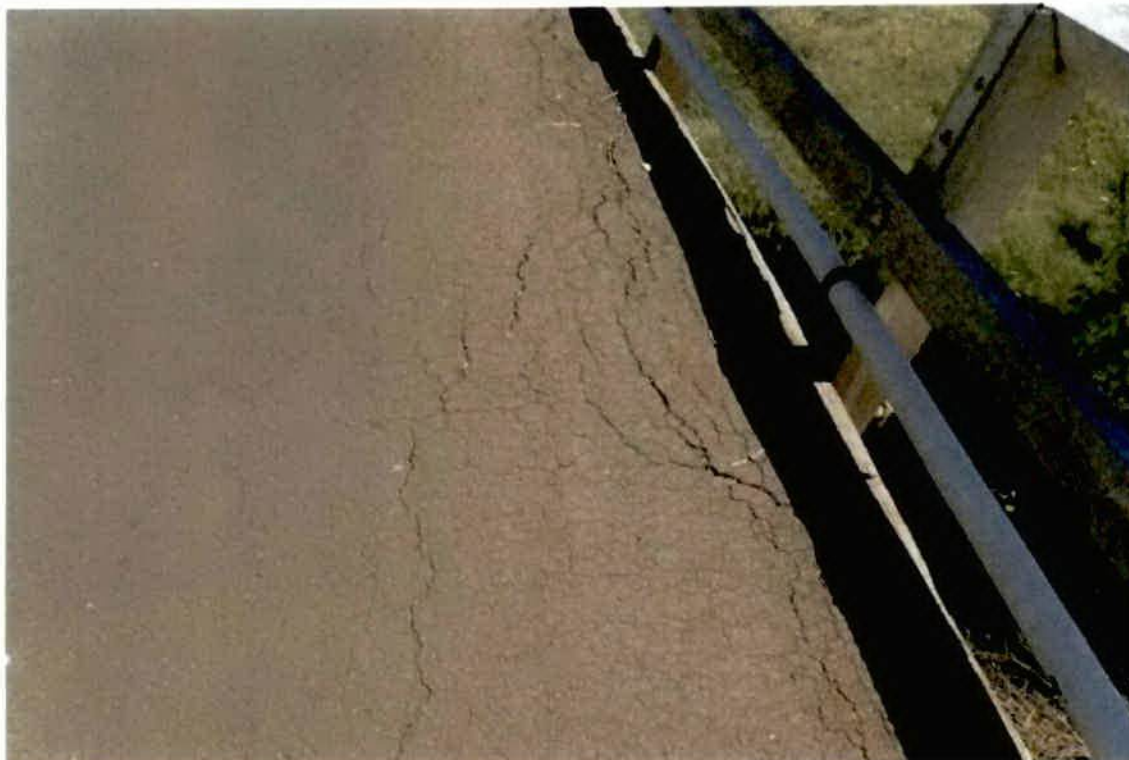
Photo No. 14: Bitumen seal cracking along kerb line from abutment 1. (Taken: 24-Jan-2018)

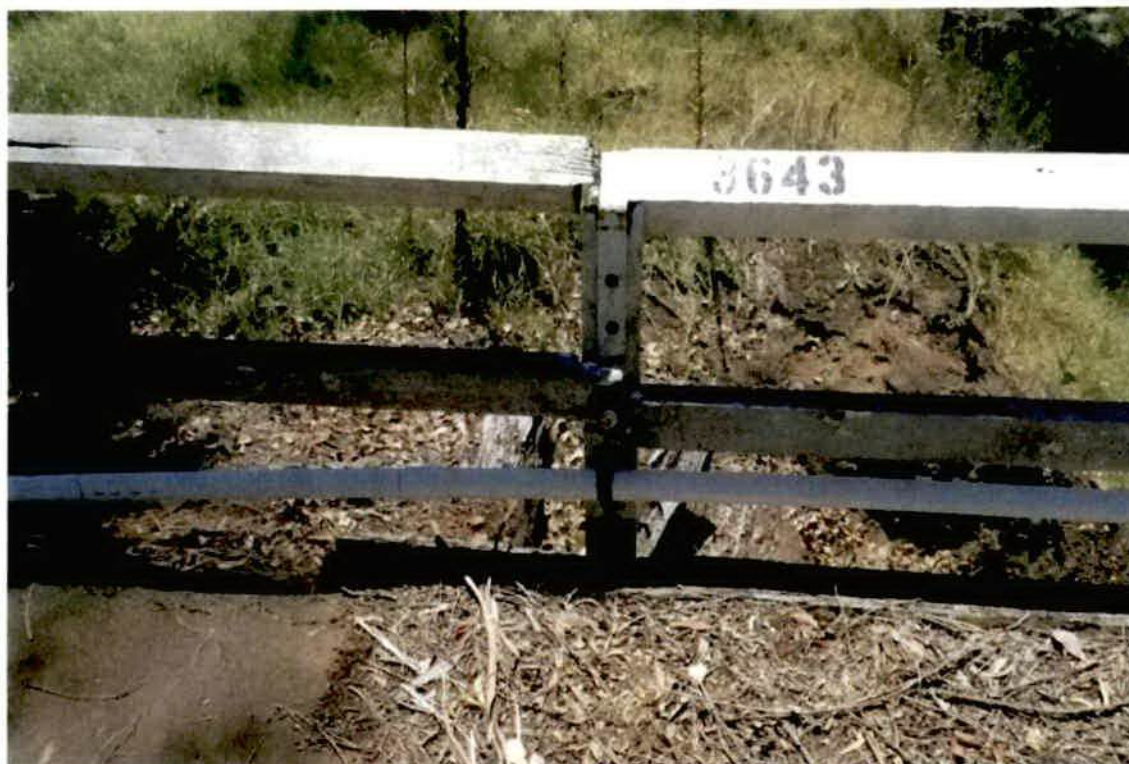
Photo No. 16: Abutment 2 right hand side barrier, broken. (Taken: 24-Jan-2018)

See photo + A2 RHS barrier is broken: See photo

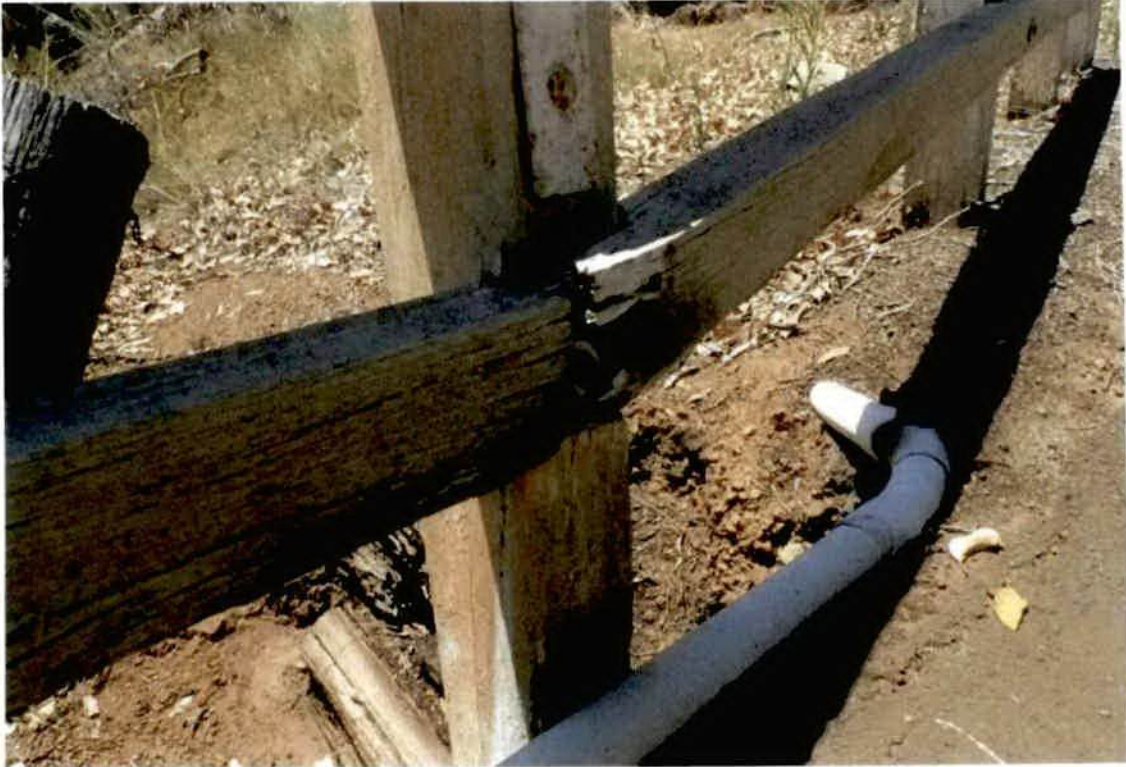
Photo No. 17: Right hand side rail damaged at corner, abutment 1. (Taken: 24-Jan-2018)

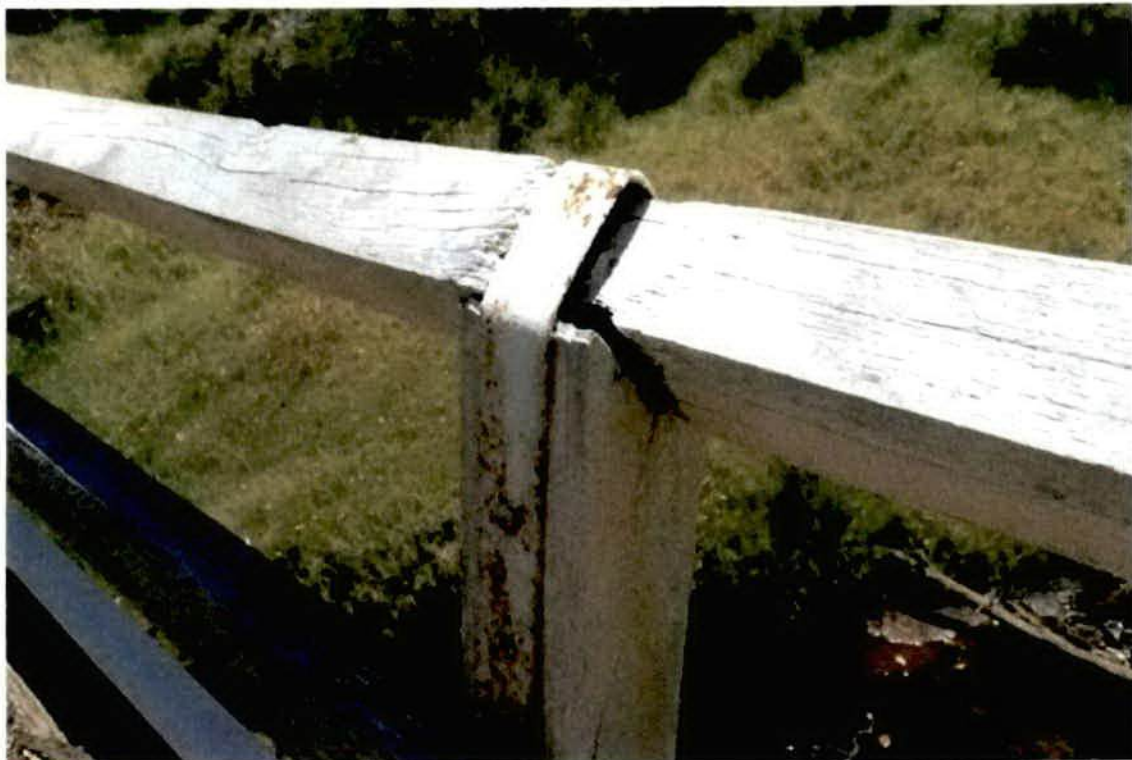
Photo No. 18: Right hand side top rail, above pier 1 damaged. (Taken: 24-Jan-2018)

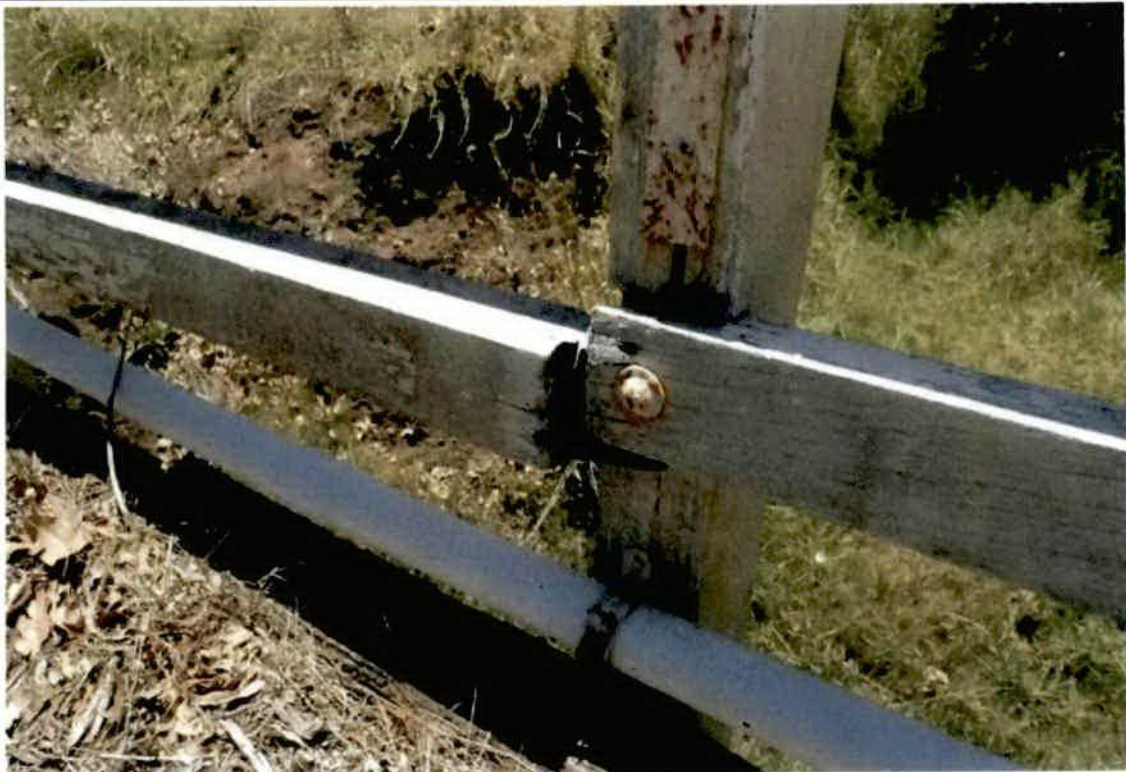
Photo No. 19: Right hand side bottom rail, abutment 2 end damaged. (Taken: 24-Jan-2018)

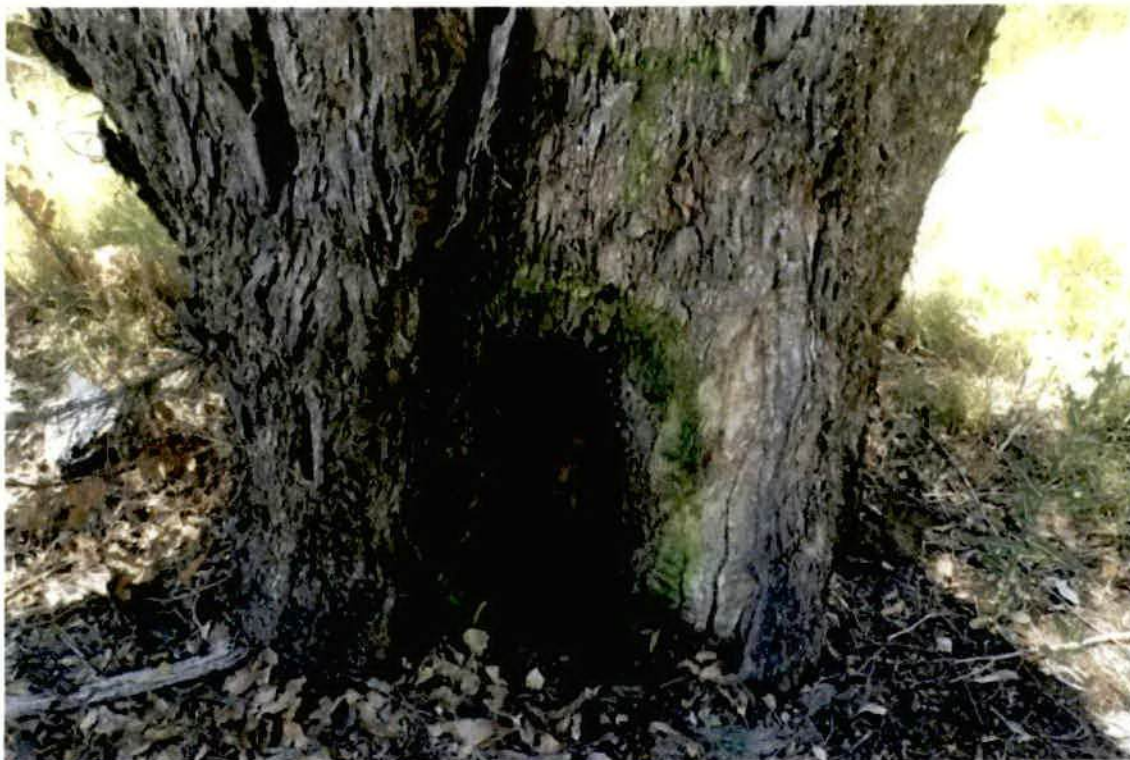
Photo No. 20: Termite nest in base of tree at abutment 2 right hand side, at barrier termination. (Taken: 24-Jan-2018)

Undertake termite inspection and treatment as required in accordance with specification 850.93.09.
Vegetation and Debris clearing shall be undertaken as outlined in report in accordance with specification 850.93.08.
Correct road surface on bridge deck and approaches as outlined in report.
Undertake guardrail maintenance as outlined in report.
Replace signs and lights as outlined in report.

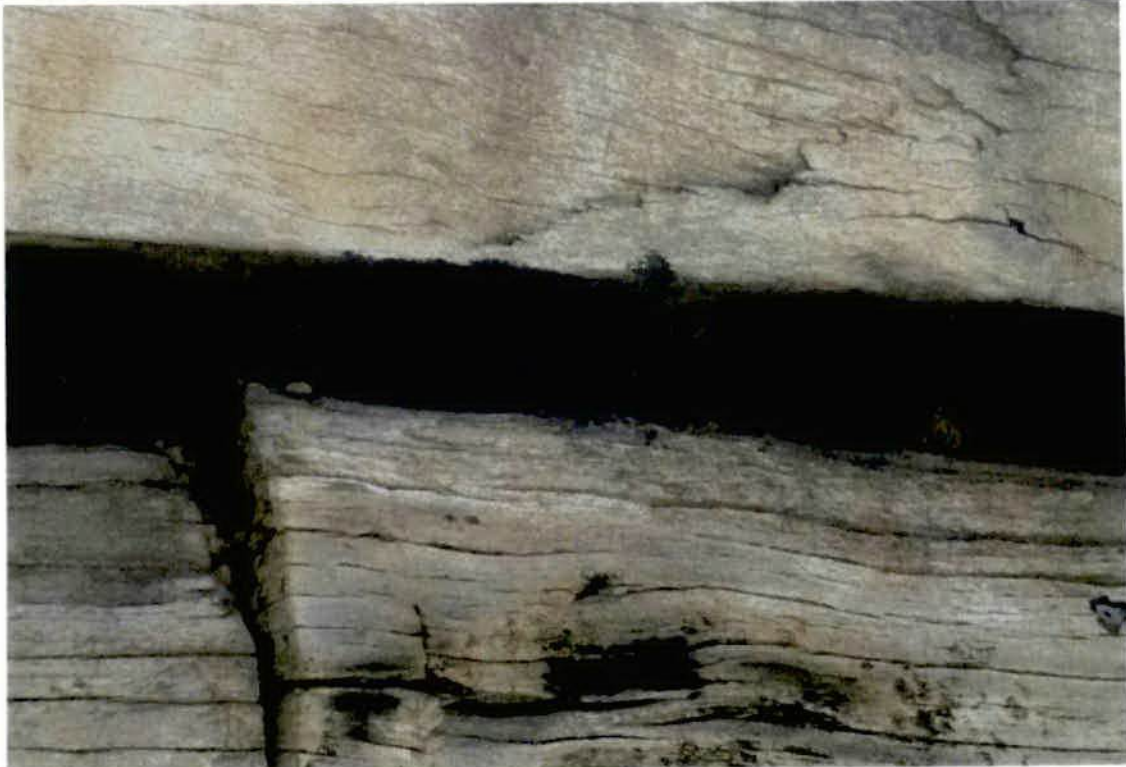
Photo No. 21: Span 3, 6 unsound deck ends from pier 3 towards abutment 2. (Taken: 24-Jan-2018)

Undertake timber decking repairs as outlined in report.
(spans 1 & 2 LHS, spans 1 to 3 RHS)
Undertake bedlog repairs as outlined in report.
(wingwalls a1 & a2 LHS & RHS)
Bolt and or seal stringers as outlined in report in accordance with specification 850.29/850.30
(span 2 str 2 & 5)

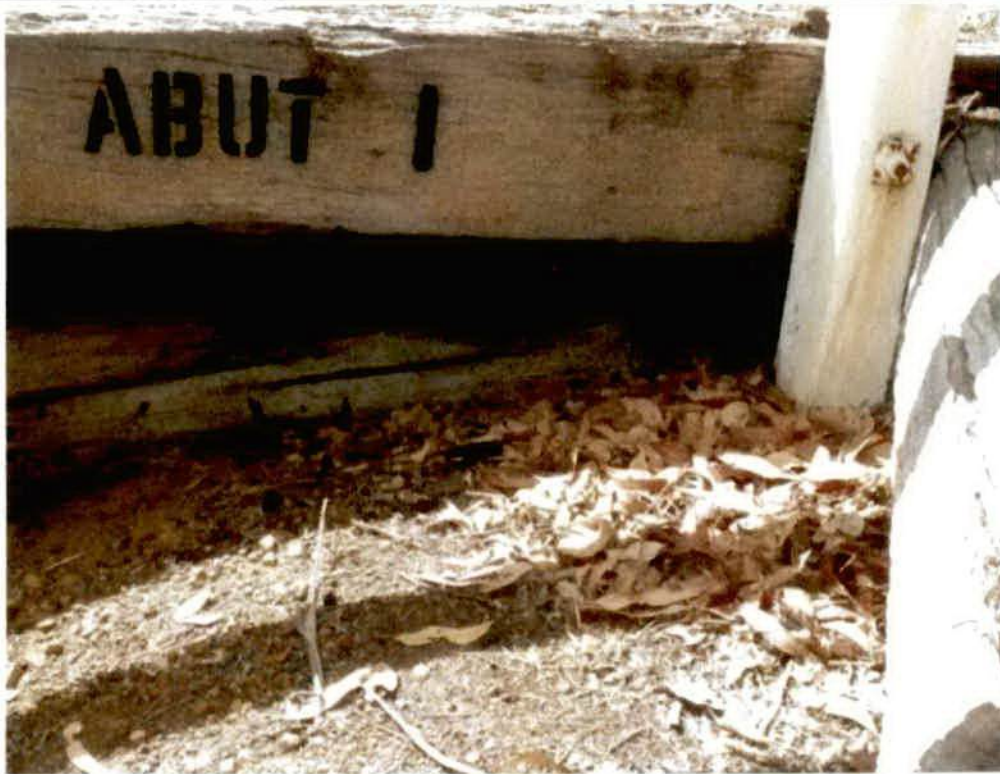
Audit Photo No. 1: Span 1 LHS, deck ends U/S. (Taken: 15-Mar-2018)

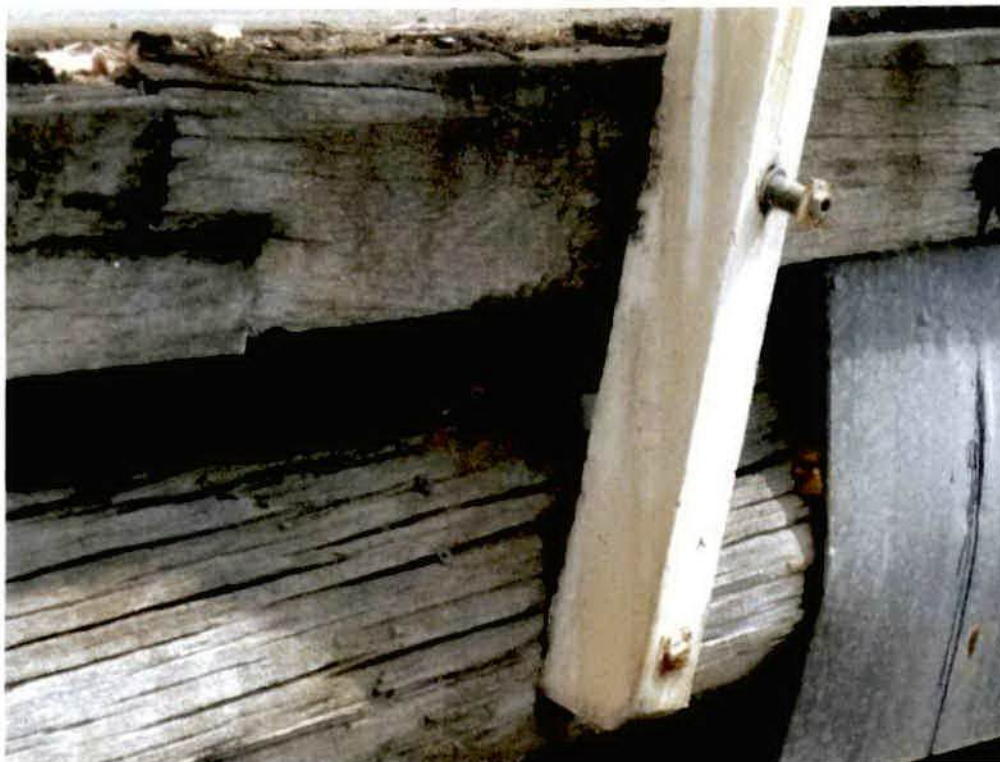
Audit Photo No. 2: Span 1 RHS, deck ends intermittently U/S. (Taken: 15-Mar-2018)

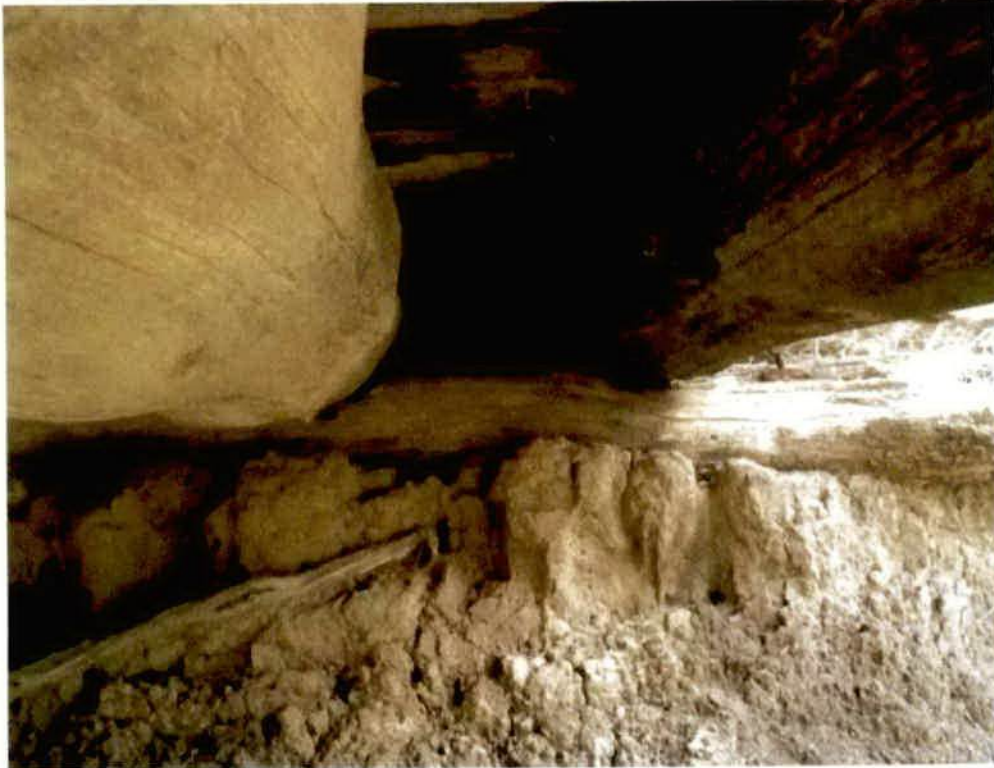
Audit Photo No. 3: Abutment 2 bedlog RHS, scour is beginning to compromise footing. (Taken: 15-Mar-2018)

Comments: both W/Wall Bedlogs are in poor Condition
 Heavy Scouring of face
 POSSIBLE MOVEMENT IN ABUTMENT 2 BEDLOG SUPPORTS IS
 POOR RHS - SEE SUBJECT PHOTOS

Undertake scour repairs as outlined in report.
(abutment 2)
Undertake works to improve access for elements not inspected.
(spans 1 & 3)
